Restoration Feasibility Study: Site Report McInnis Marsh, Marin County, California

Kamman Hydrology & Engineering, Inc.

June 1, 2015

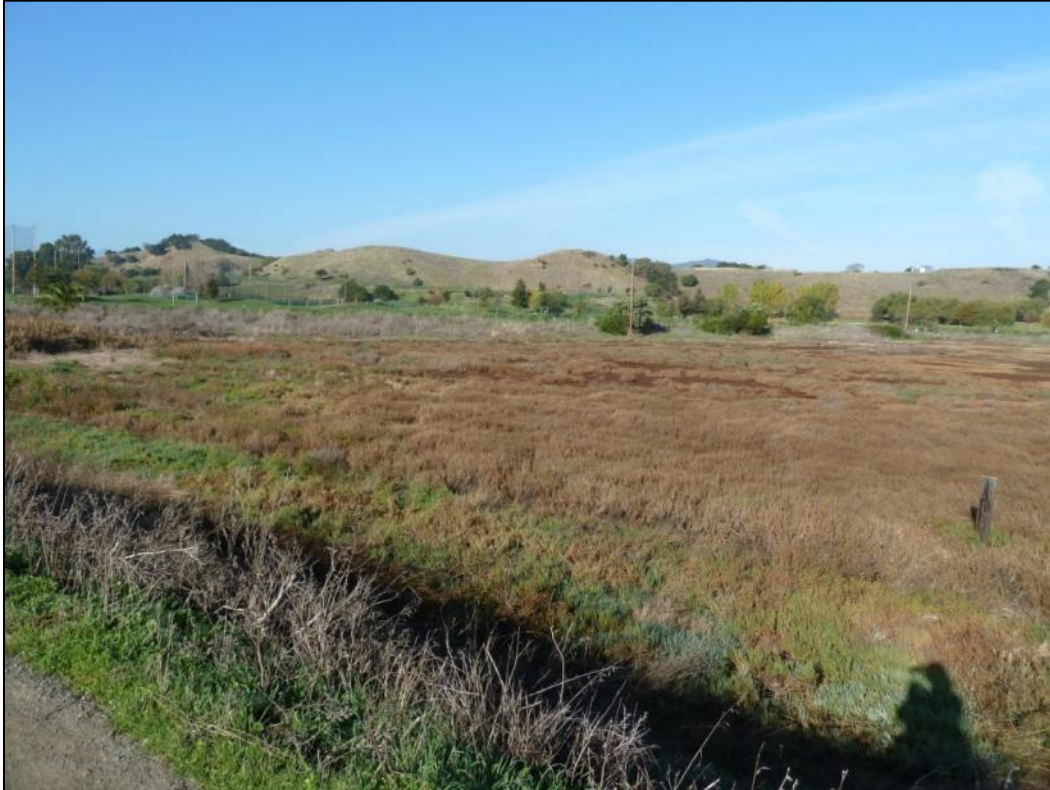
Figure 2-1: McInnis Marsh from South Levee to Western Boundary and McInnis Golf Course

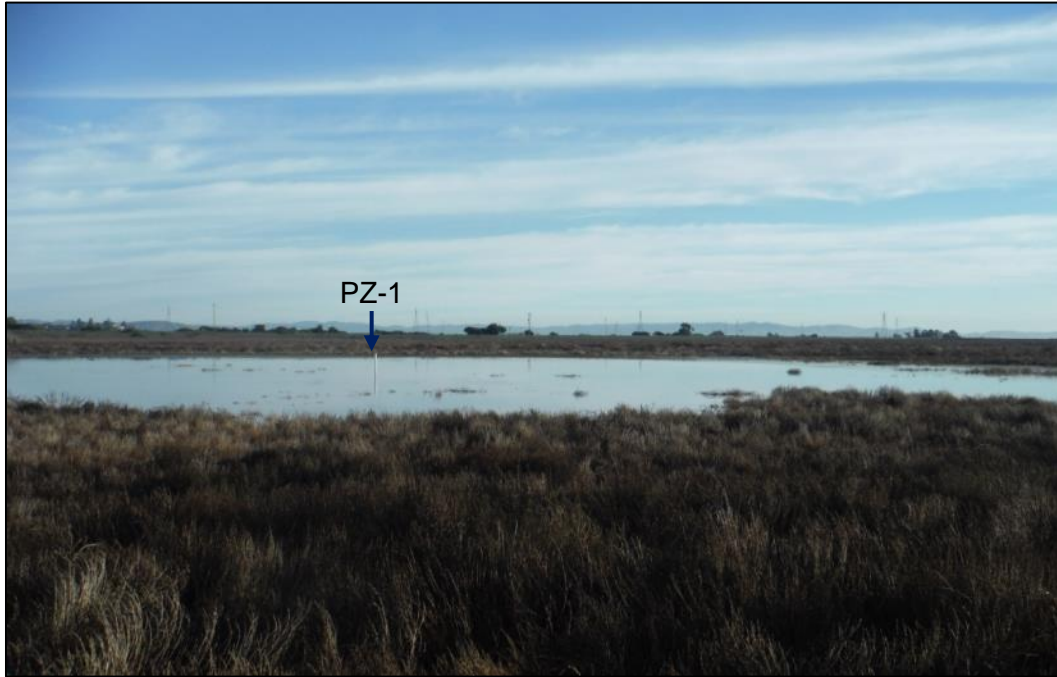
Figure 2-5: Wet Season Conditions at the inner subsided marsh salt panne near PZ-1

Hydrologic conditions were characterized at McInnis Marsh via observations and measurements of both surface water and groundwater levels between the time period of June 2014 and March 2015. KHE installed four (4) shallow groundwater piezometers (PZ-1 through PZ-4), three instruments inboard of perimeter levees and one outboard of the Eastern levee in the adjacent undiked marsh (Figure 2-2). A stilling well was also installed at the Park's tide gate (TG-1). Continuous water level measurements were collected on a 15 minute sampling interval to characterize tidal water fluctuations along the North Fork of Gallinas Creek. Continuous water level monitoring was performed both in Gallinas Cr and in the interior of McInnis Marsh at PZ-1 for an approximately 8 month period (6/19/14 – 2/17/15). The Gallinas Creek water level instrument was installed on the southwest pier of the tide gate (TG-1) on the North Fork of Gallinas Creek. (Figure 2-29) The PZ-1 logger was installed inside the well casing in the largest tidal pond/panne in the subsided basin (see Figure 2-5 and Figure 2-6 for photos of PZ-1).

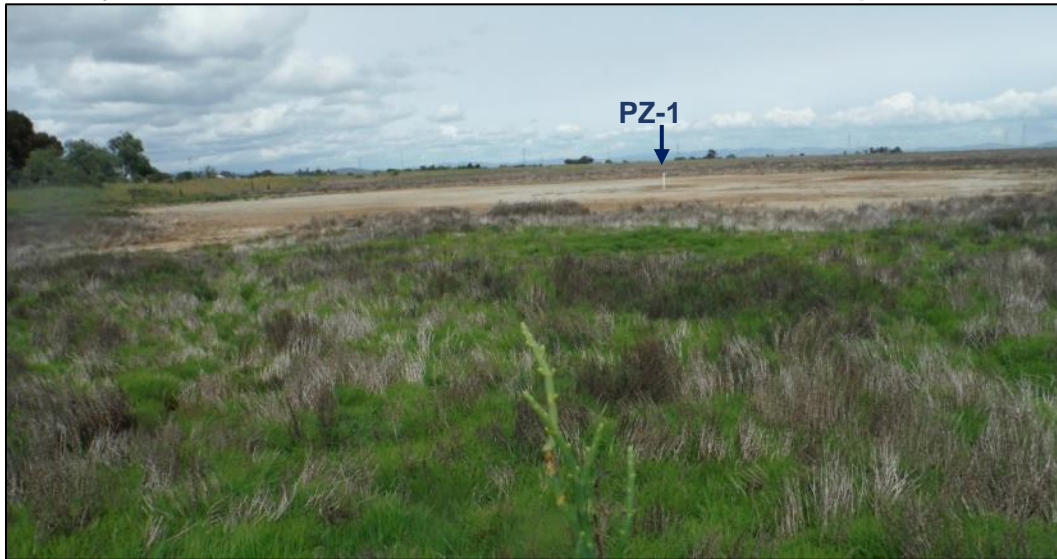
Figure 2-6: Dry Season Conditions at the inner subsided marsh salt panne near PZ-1

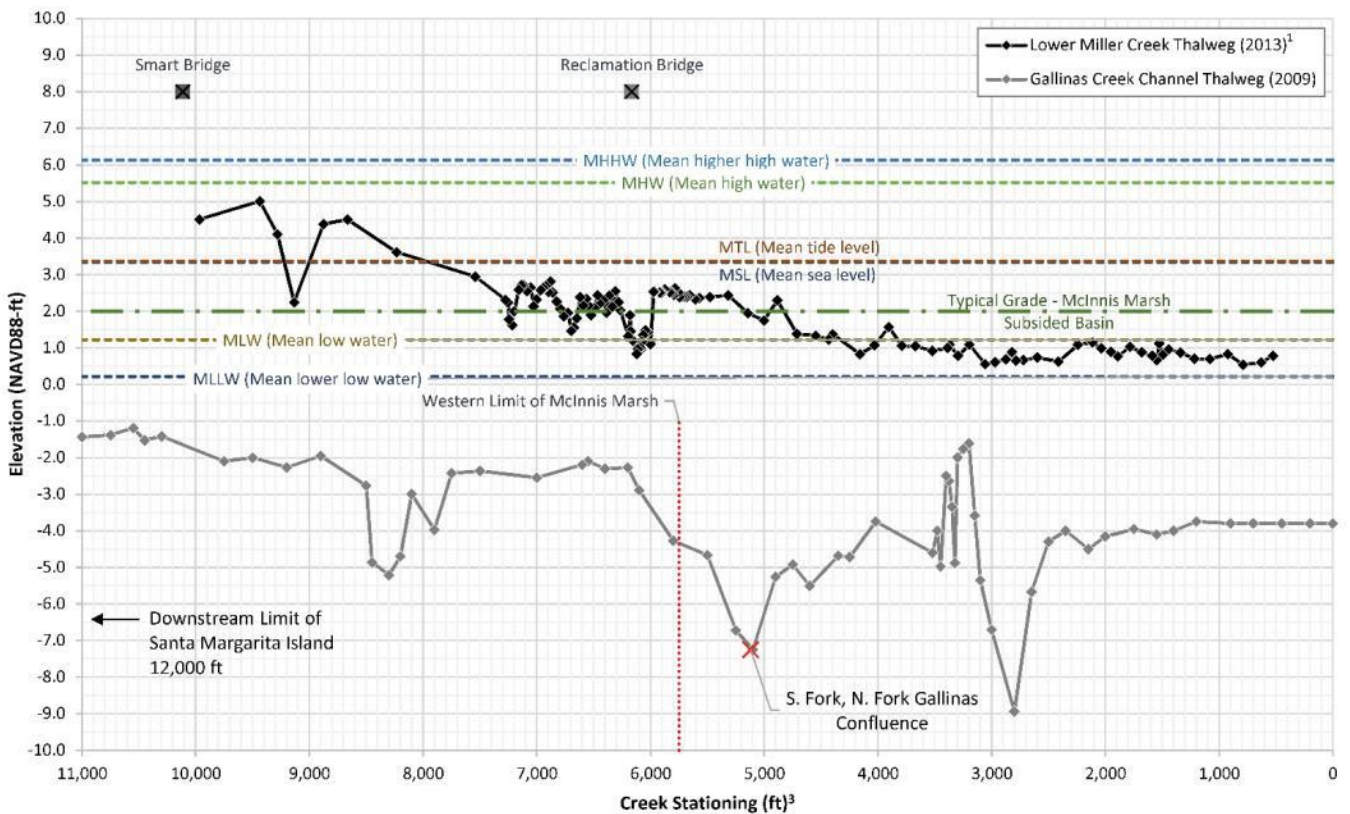
Figure 2-11: Longitudinal Profiles along Miller Creek and Gallinas Creek channel thalweg

¹Miller Creek thalweg elevations are a combination of channel surveys conducted by L.A. Stevens & Associates, Inc. (stations 526 ft through 548 ft) and Terra Firma Surveys, Inc. (Stations 5,570 through 9,969) from LGVSD Channel Surveys, (KHE, 2013).

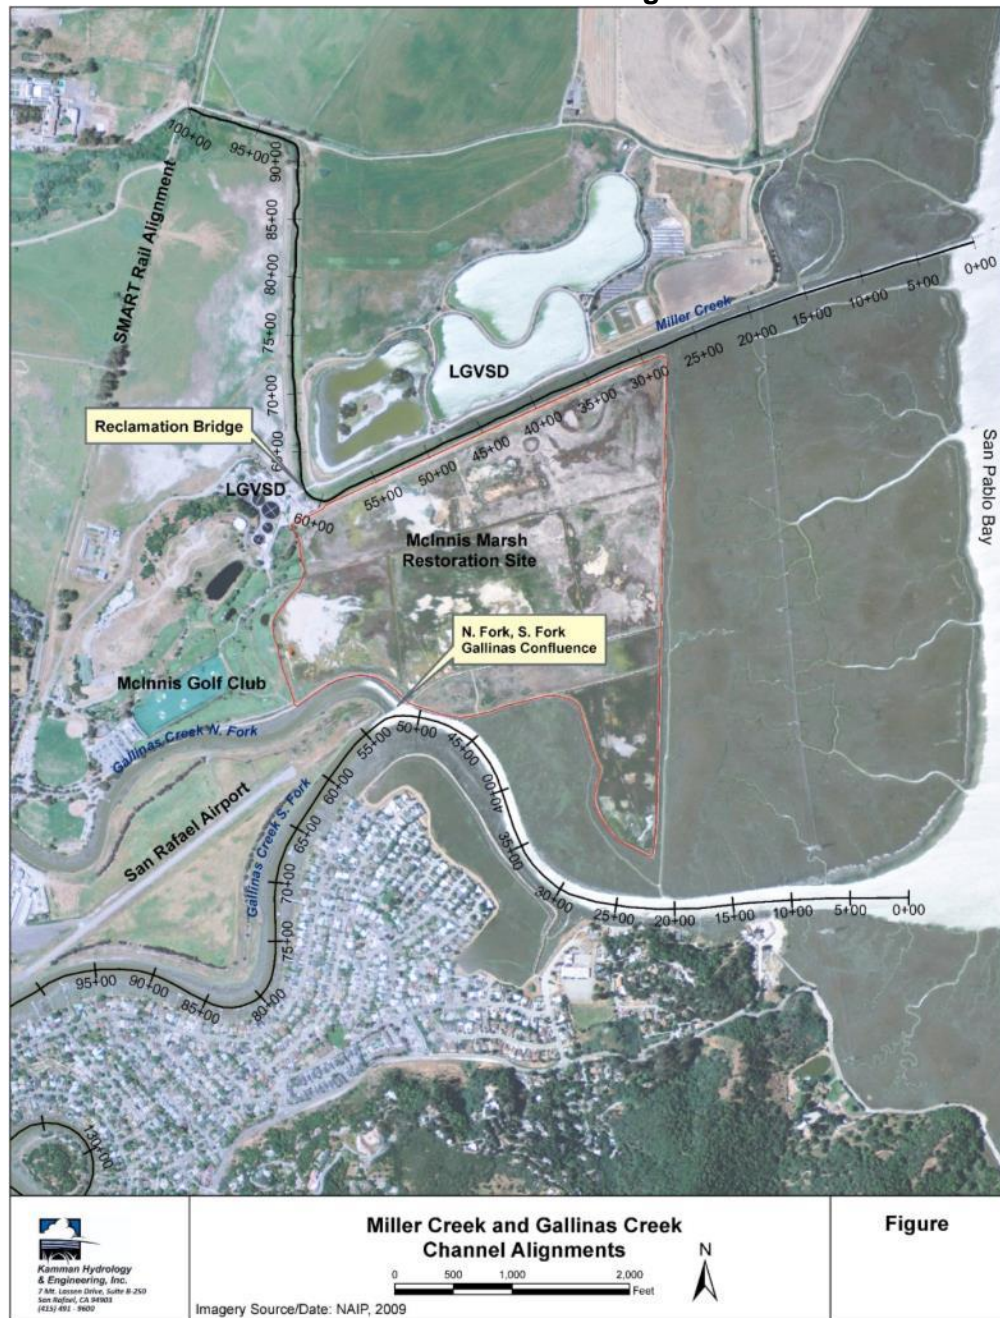
Figure 2-12: Miller and Gallinas Creek Profile Stationing

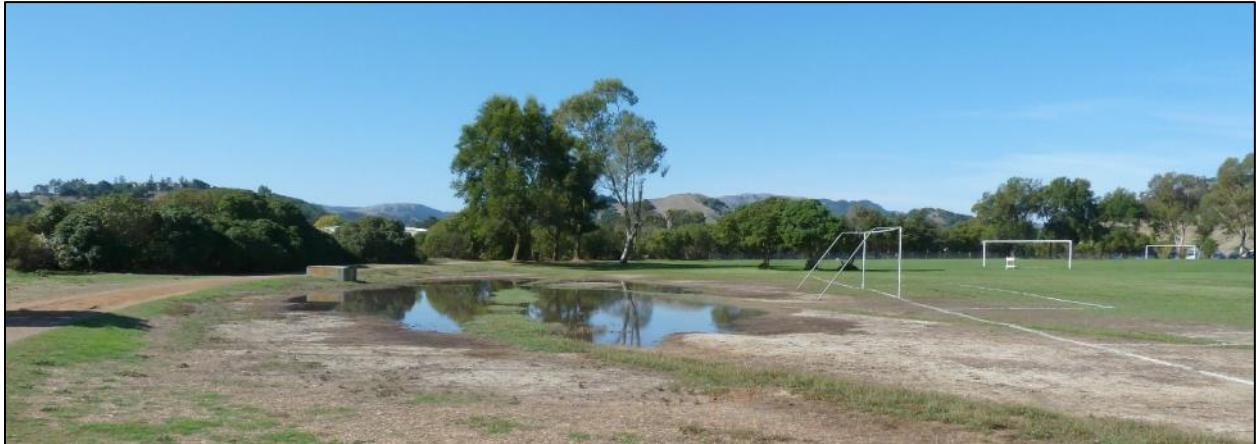
Figure 2-19: Surface Ponding at McInnis Soccer Field

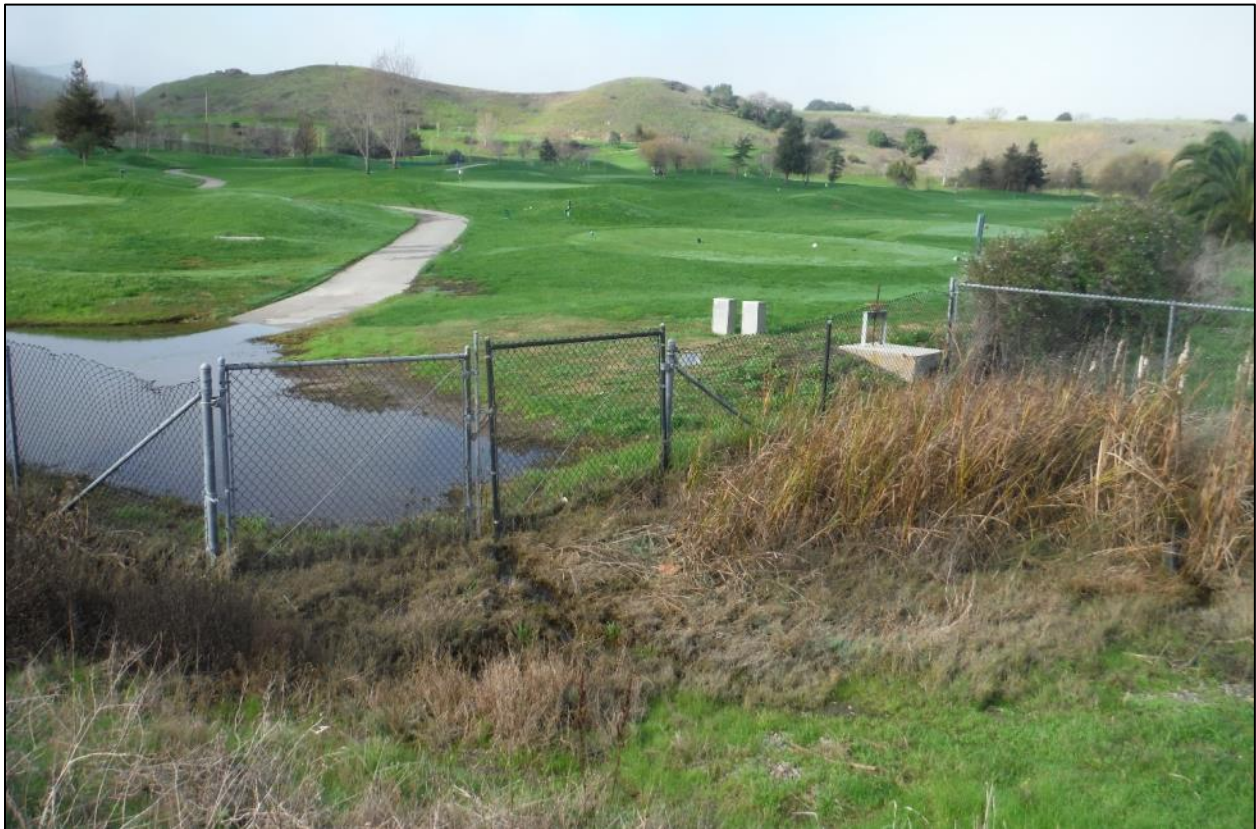
**Figure 2-20: Surface Ponding at McInnis Golf Course
Levee Crest Elevations**

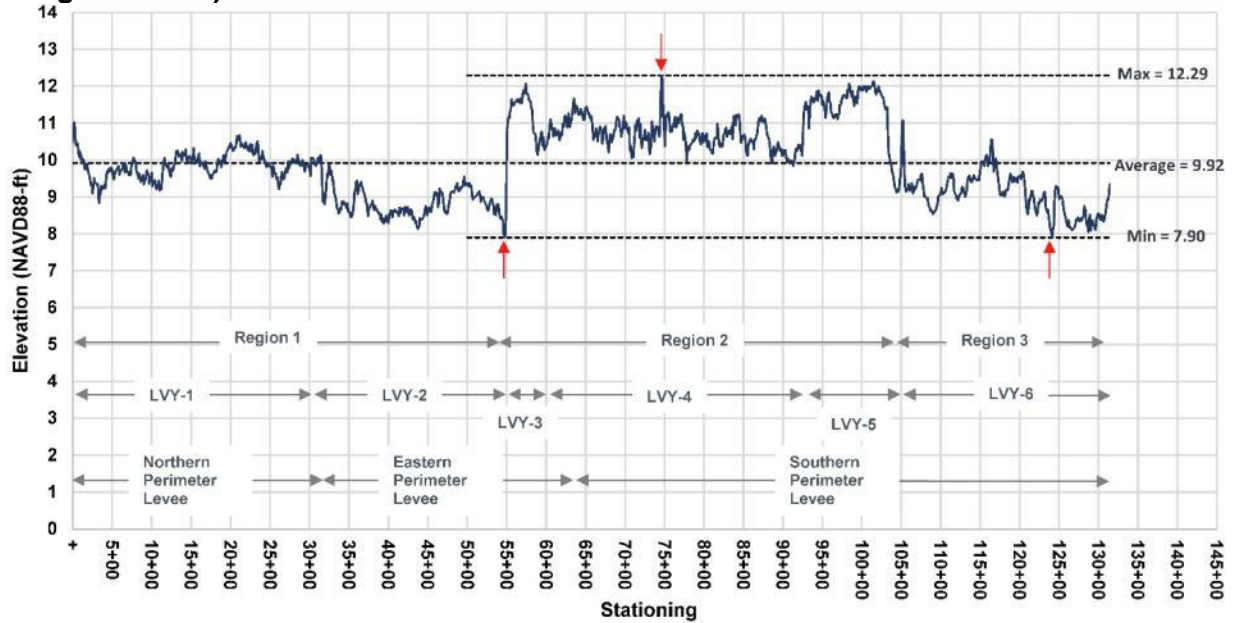
Figure 2-21: McInnis Marsh Perimeter Levee Profile (Sampled from 2010 USGS LiDAR along Levee CL)

To evaluate inundation and overtopping risks for the existing perimeter levee and trail system, KHE extracted levee top elevations from the project DEM. Stationing along the alignment was oriented clockwise along the levee perimeter extending from a northern point near LGVSD's Reclamation Bridge to the southern levee near the McInnis Golf Club parking lot . The alignment length was approximately 2.5 miles. Levee crest elevations along this transect range from 7.9 to 12.3 ft. KHE identified relative low points along the levee (less than the predicted 9 ft. (50-yr. return period storm water level maxima for existing conditions) at two locations: adjacent to the outboard marsh between stations 30+00 and 55+00, and along the primary trail adjacent to the

The elevation profile of the levee tops along the outer perimeter of McInnis Marsh were categorized into three (3) regions. These regions were selected based on elevation trends of the levee profile. Region 1 (Stations 0+00 – 55+00) and Region 3 (Stations 105+00 – 131+00) levee top elevations averaged at approximately 9-ft. (NAVD88-ft.). The Region 2 profile was, on average, 1.5 feet higher than the Region 1 and 3 profiles, displaying an average elevation of 10.97. Levee crest elevation statistics for each region are summarized in Table 2-6.

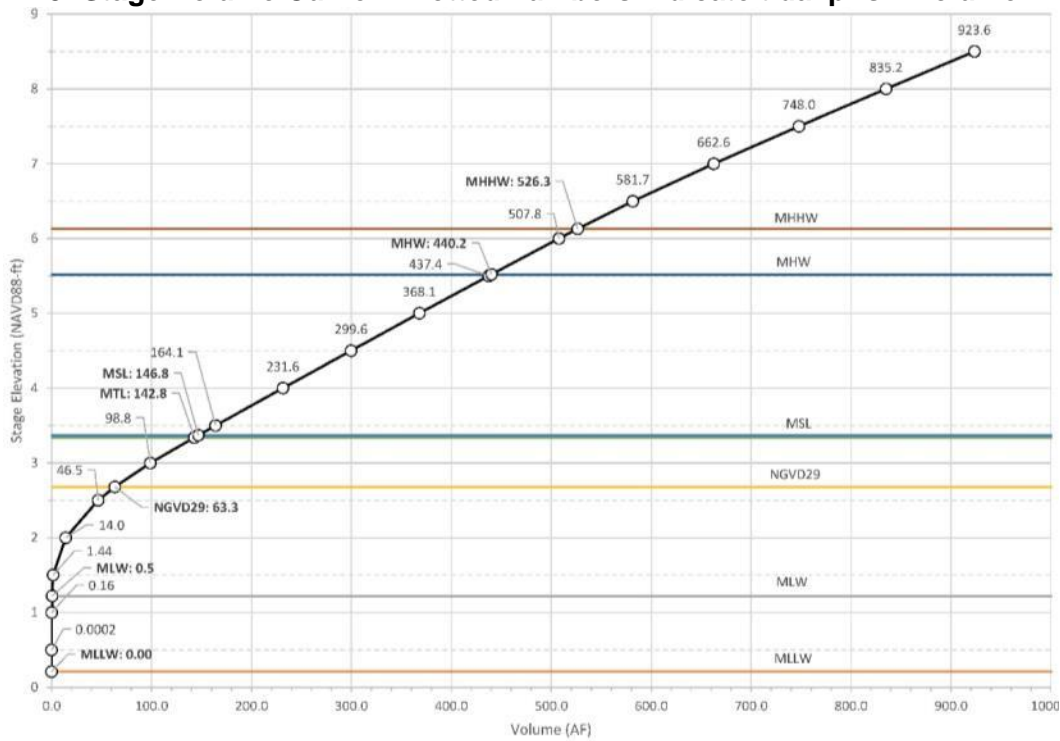
Figure 2-25: Stage-Volume Curve – Plotted numbers indicate tidal prism volume

These estimates of anticipated tidal prism and inundated marsh area will guide in restoration design to predict the size (width and depth) of the channels needed to support a healthy marsh. Figure 2-24 and Figure 2-25 present hydraulic geometry relationships for San Francisco

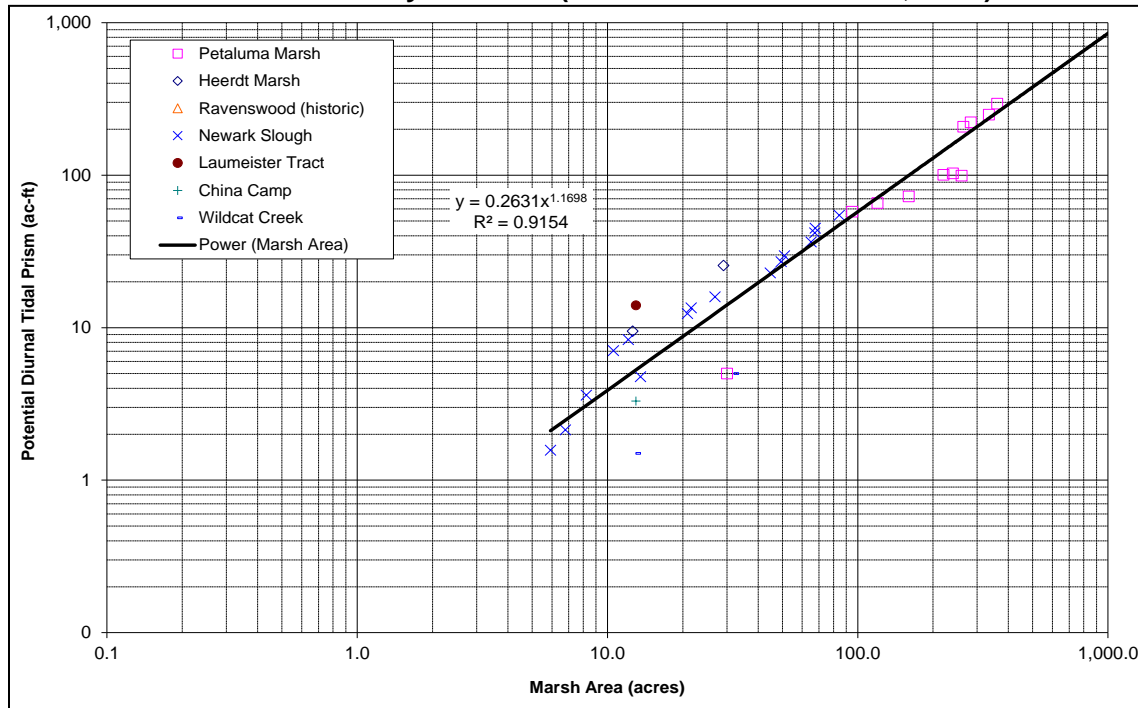
Figure 2-26: Correlation of the potential diurnal tidal prism as a function of marsh area for mature San Francisco Bay marshes (Source: PWA and Faber, 2004).

Bay marshes which describe the observed relationship between marsh area, potential tidal prism (PTP) and equilibrium (mature marsh) channel size (PWA and Faber, 2004). These San Francisco Bay hydraulic geometry relationships and estimates of McInnis Marsh MHHW marsh area and PTP (143 ac and 537 ac-ft. respectively), are used to predict the geometry of equilibrium channels expected at McInnis Marsh and the associated increase in channel geometry in Lower Gallinas Creek bayward of the restoration site.

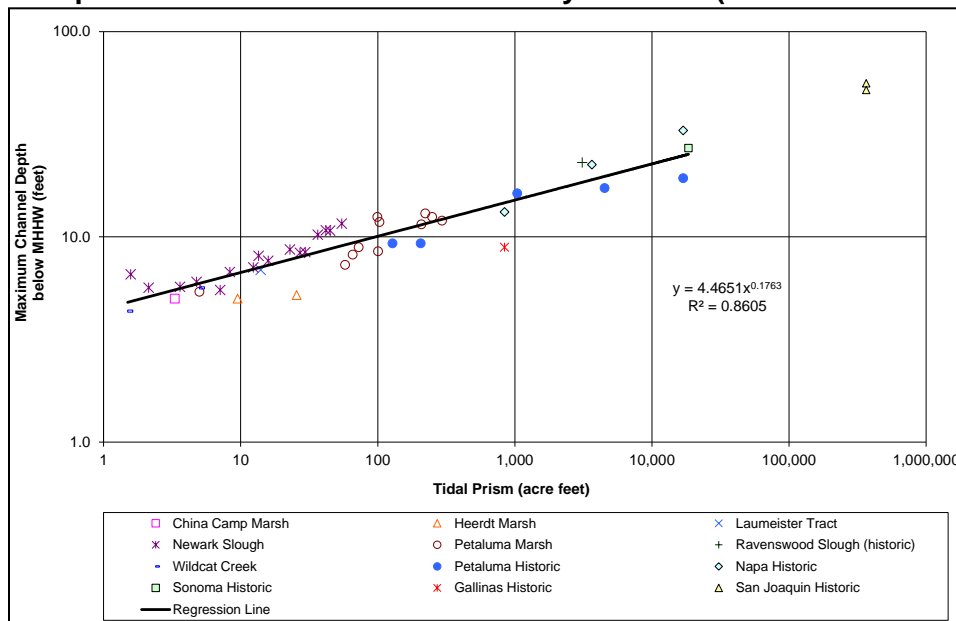
Figure 2-27: Correlation of the maximum Channel depth below MHHW as a function of tidal prism for mature San Francisco Bay marshes (Source: PWA and Faber, 2004).

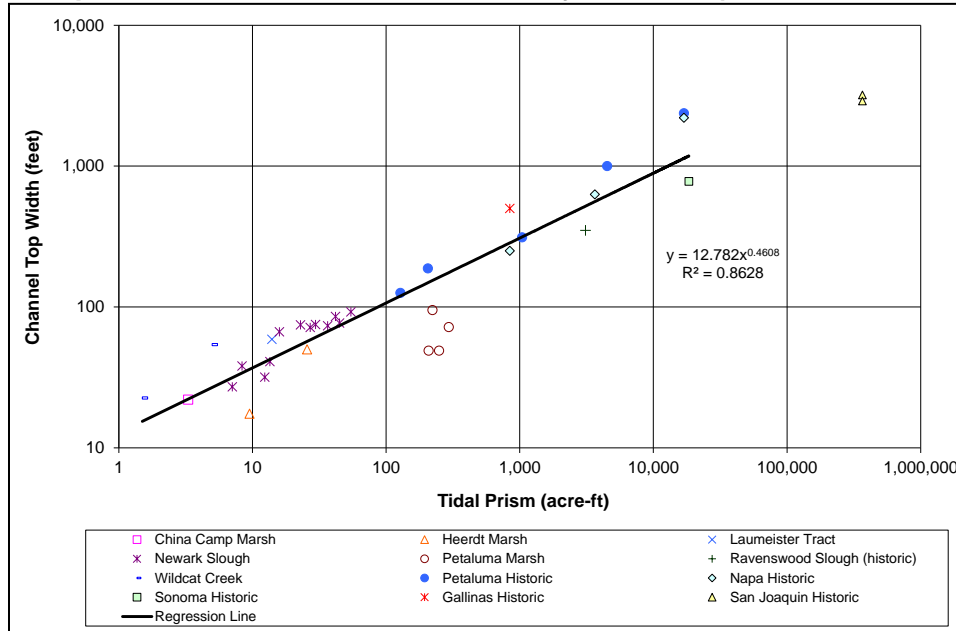
Figure 2-28: Correlation of the maximum channel top width and depth as a function of tidal prism for mature San Francisco Bay marshes (Source: PWA and Faber, 2004).

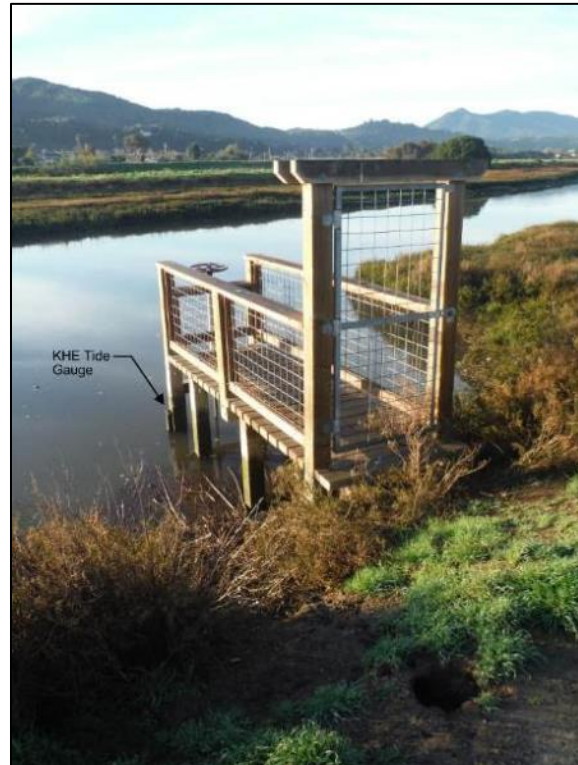
Figure 2-29: Photo of McInnis Marsh Tide Gate (TG-1) and KHE tidal monitoring stilling well (2/11/15).

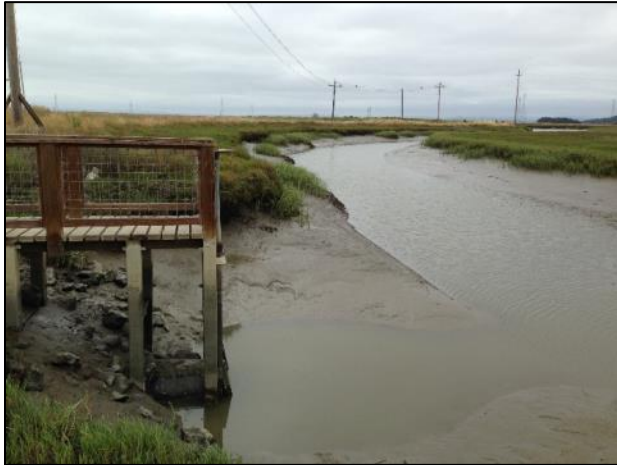
Figure 2-30: Low Tide at TG-1. Photo Taken 5/19/15, 10:20 AM

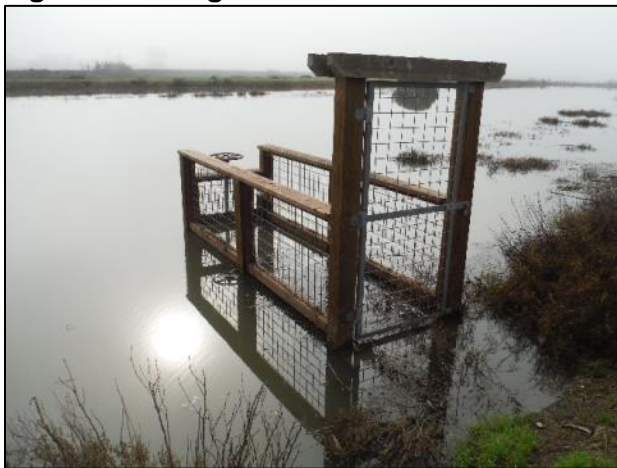
Figure 2-31: High Tide at TG-1. Photo Taken 12/22/14, 12:11 PM.

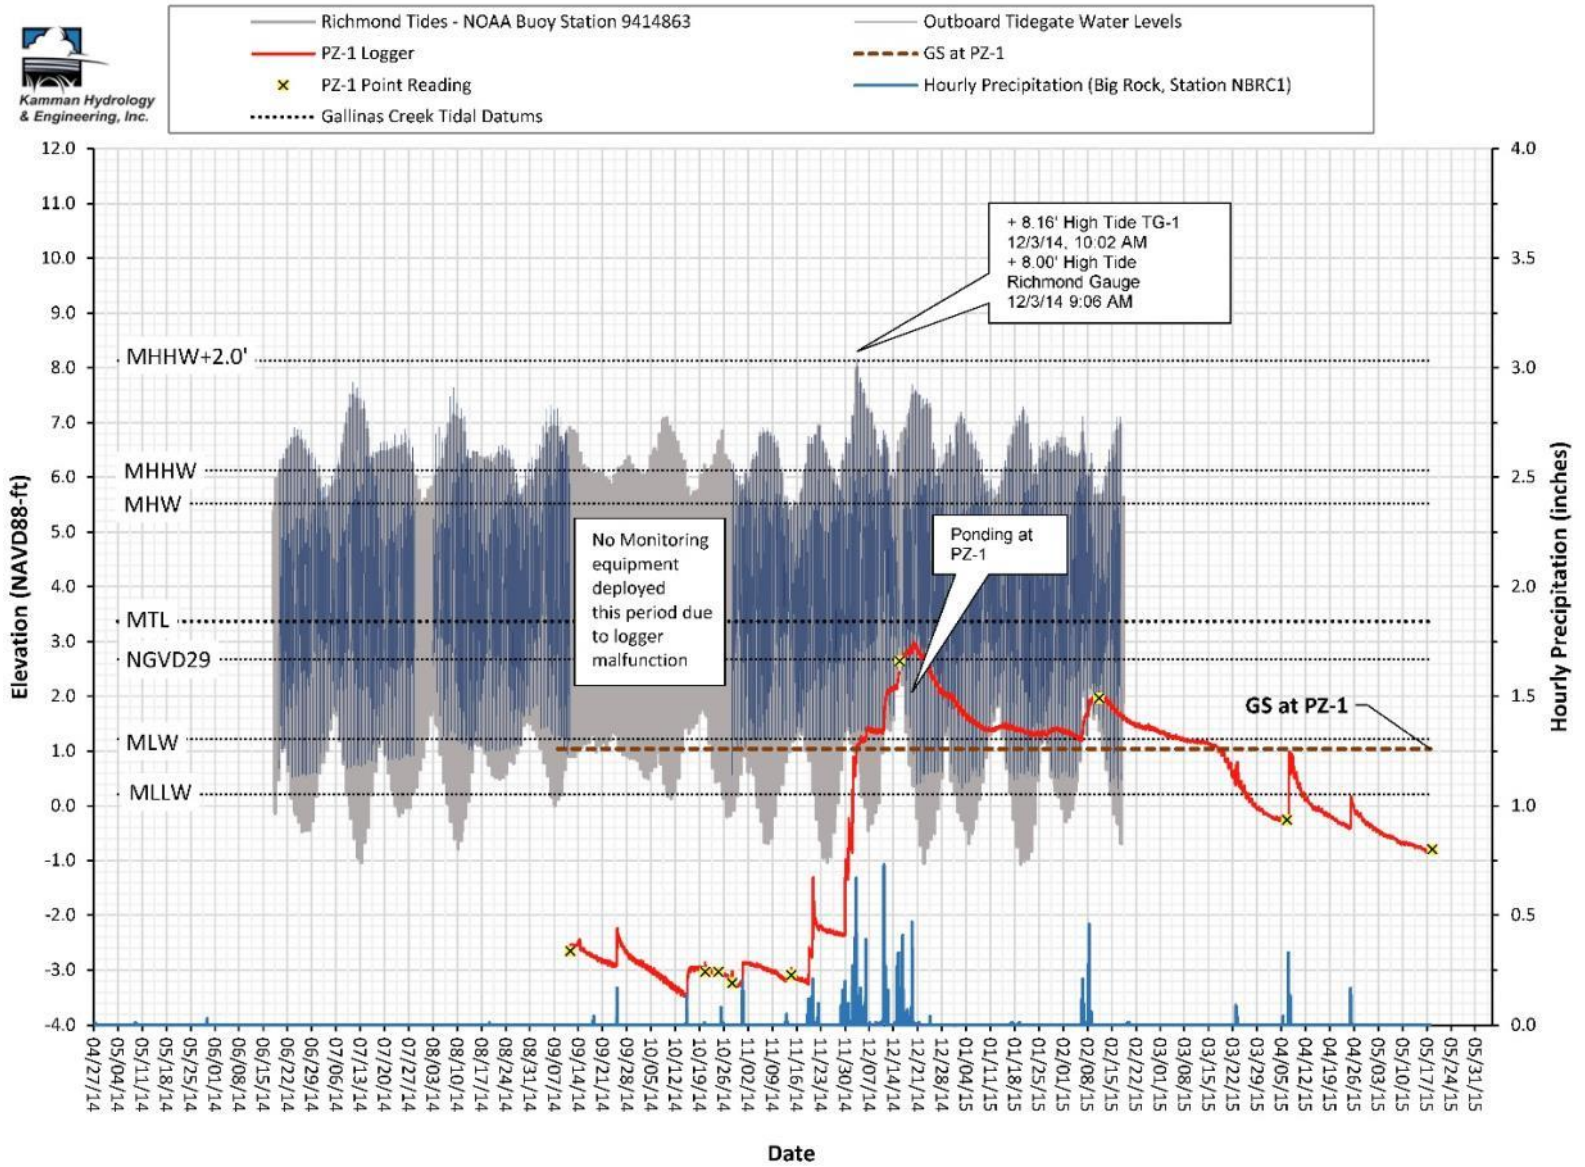
Figure 2-32: Water level monitoring results for PZ-1 and the outer tide gate at McInnis Marsh compared with NOAA tide data from station RCMC1 – Richmond CA.

Continuous water level recording at PZ-1 indicated short-term response to storms, followed by a gradual groundwater recession. Seasonal groundwater rises within the basin due to wet season recharge. Up to 2 ft. of wet season ponding was observed at PZ-1 between early December and mid to late March due to direct precipitation and runoff. Dry season recession was observed from winter groundwater conditions towards spring conditions (Figure 2-32). No tidal influence was observed for groundwater levels at PZ-1.

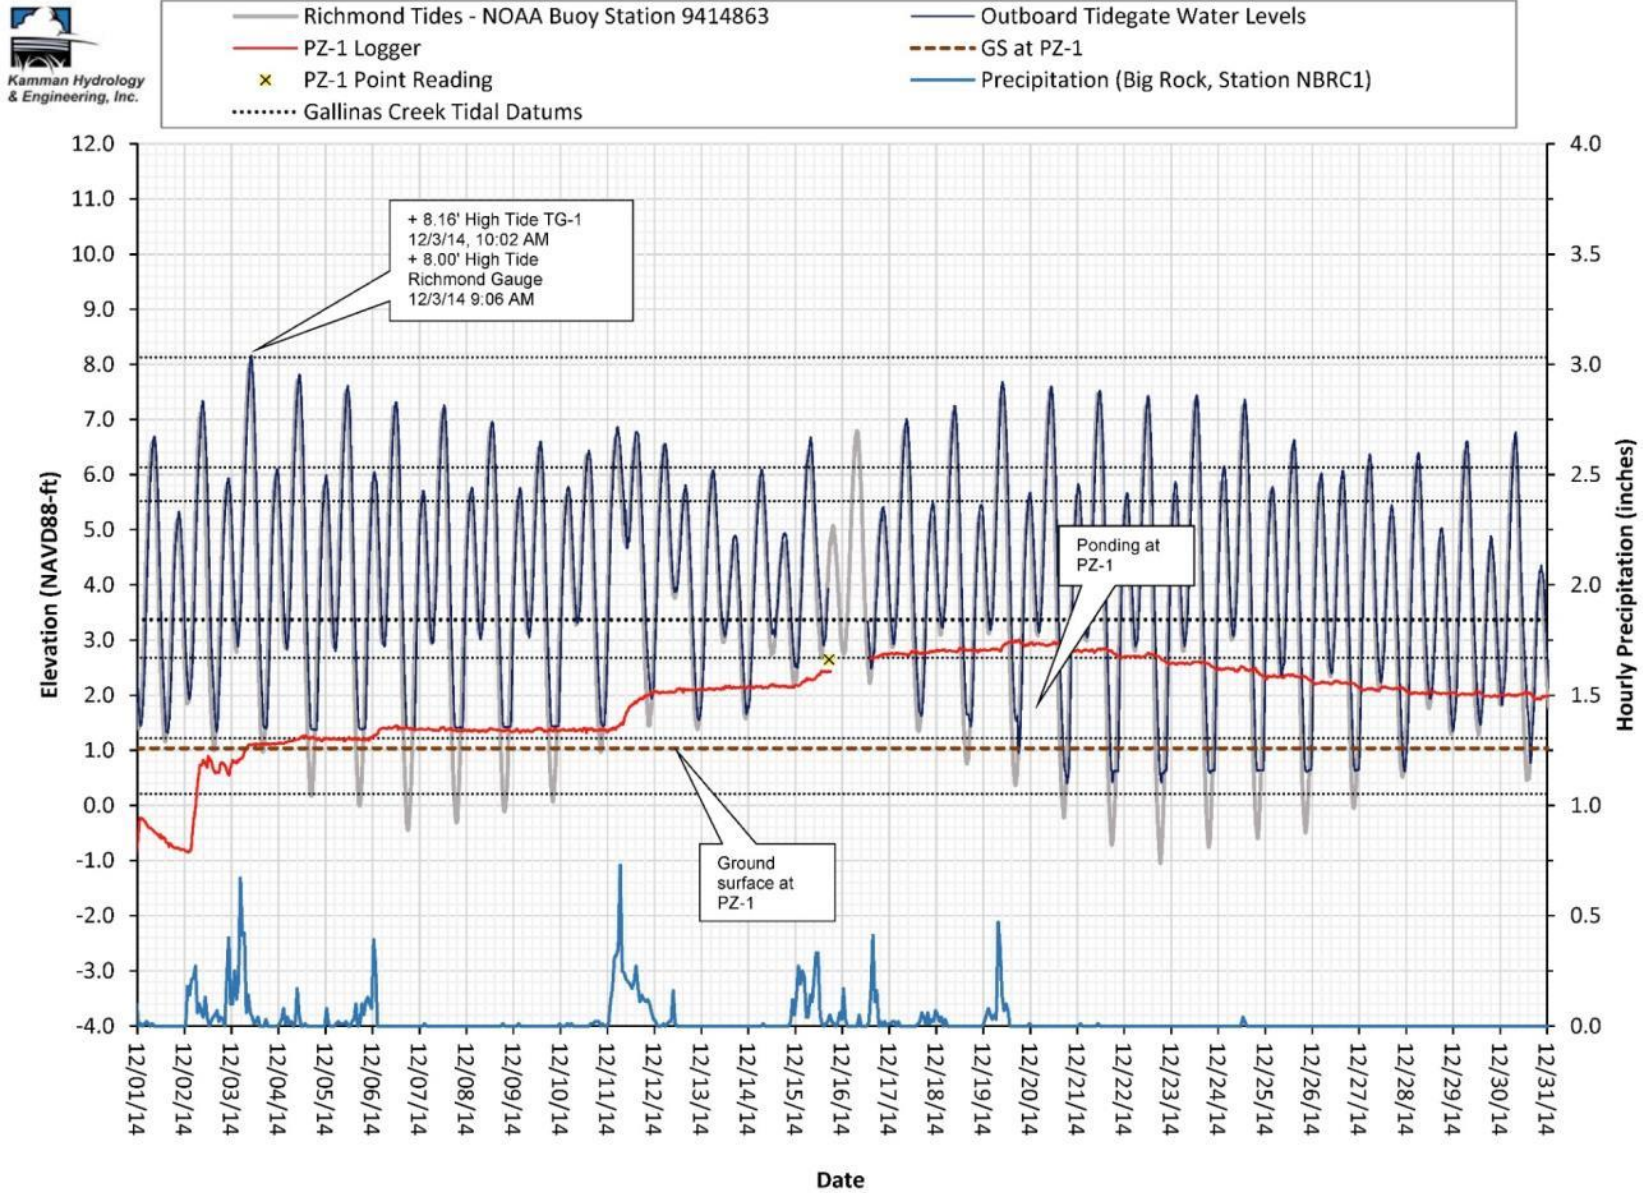
Figure 2-33: Water level monitoring results during December 2014 storm and high tide events.

Point observations indicate similar groundwater conditions at PZ-1, PZ-2 and PZ-4, on the interior subsided marsh region (Figure 2-34 and Figure 2-35). Dry summer water level conditions for the subsided interior marsh show water levels ranging from -4 feet to -2 feet (NAVD88). Observed wet winter conditions that resulted from storms in mid-December 2014 caused groundwater levels on the subsided interior marsh to increase from the dry late summer levels by 5-6 ft. at the ground surface at PZ-2 and PZ-4 to approximately +3.0 ft., NAVD88. As discussed above, long-term seasonal ponding occurs at PZ-1. Here, average grades are approximately 5-ft lower (1.5-3.0 ft., NAVD88) than the adjacent undiked marsh (6-7 ft., NAVD88). Post precipitation events in the subsided interior marsh result in a smooth groundwater recession toward dry summer month water levels at (-4ft - -2ft, NAVD88). Groundwater levels in the outboard marsh at PZ-3 did not change much during the monitoring period (Figure 2-32 and Figure 2-33), with groundwater levels remaining at or near the marsh plain surface.

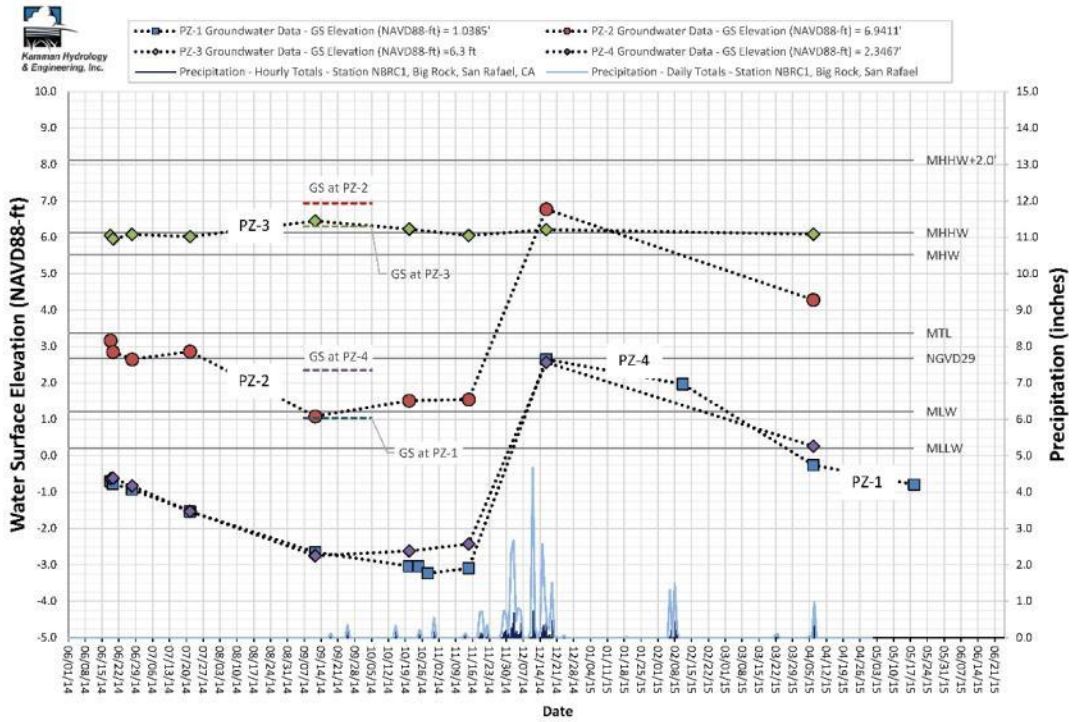
Figure 2-34: Groundwater Elevation (NAVD88) at KHE Gauges

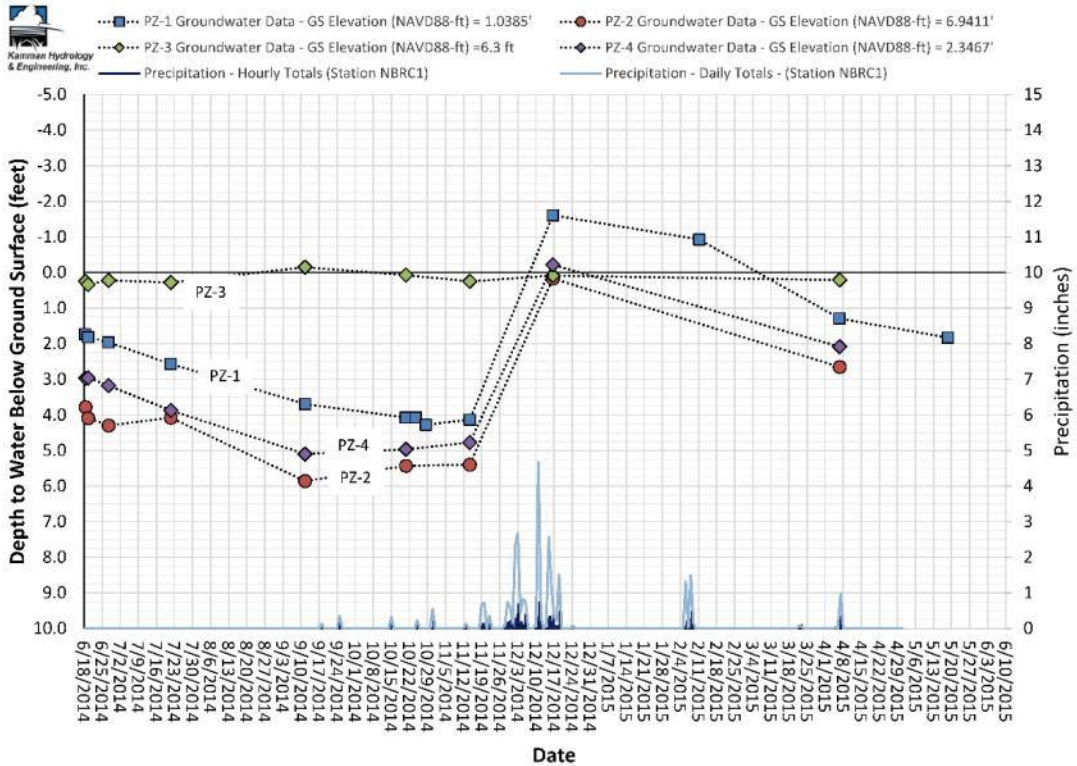
Figure 2-35: Depth to water readings for KHE Gauges

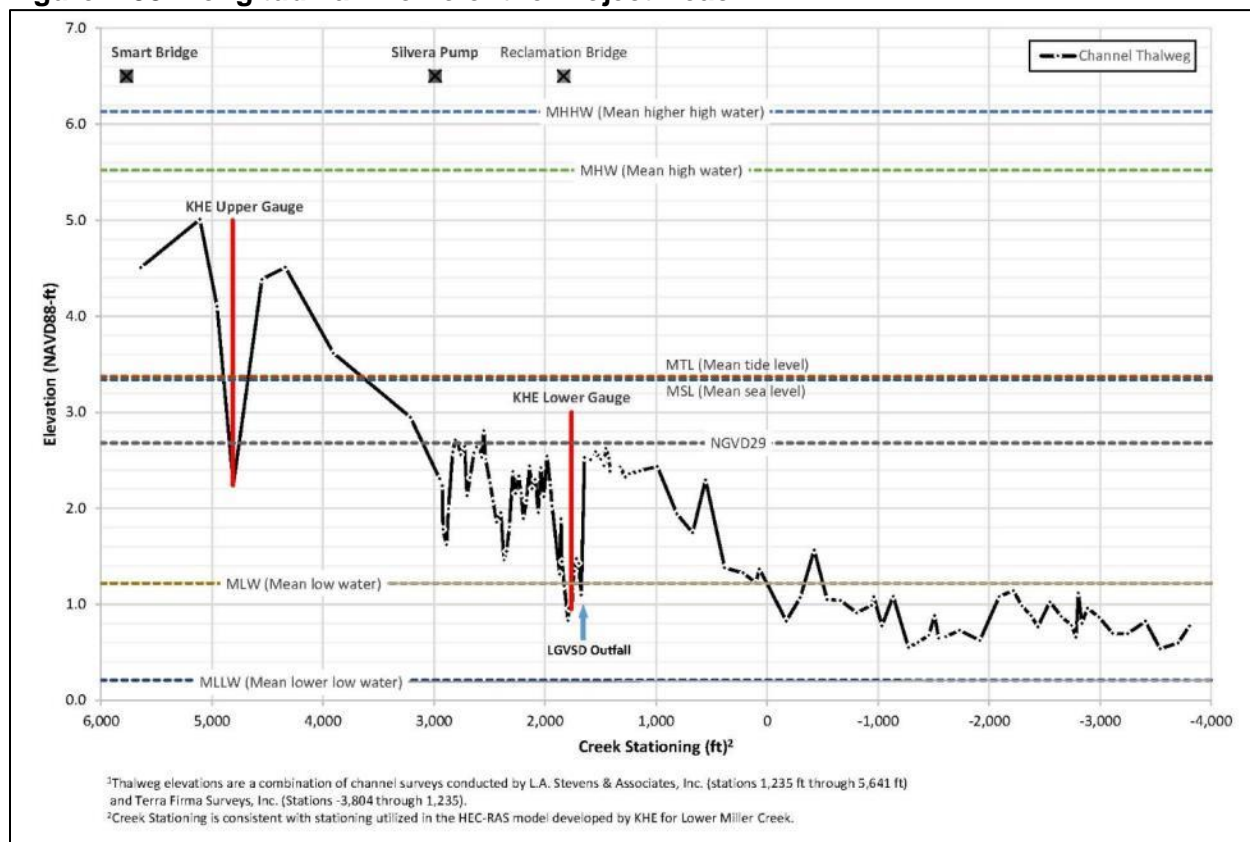
Figure 2-38: Longitudinal Profile of the Project Reach

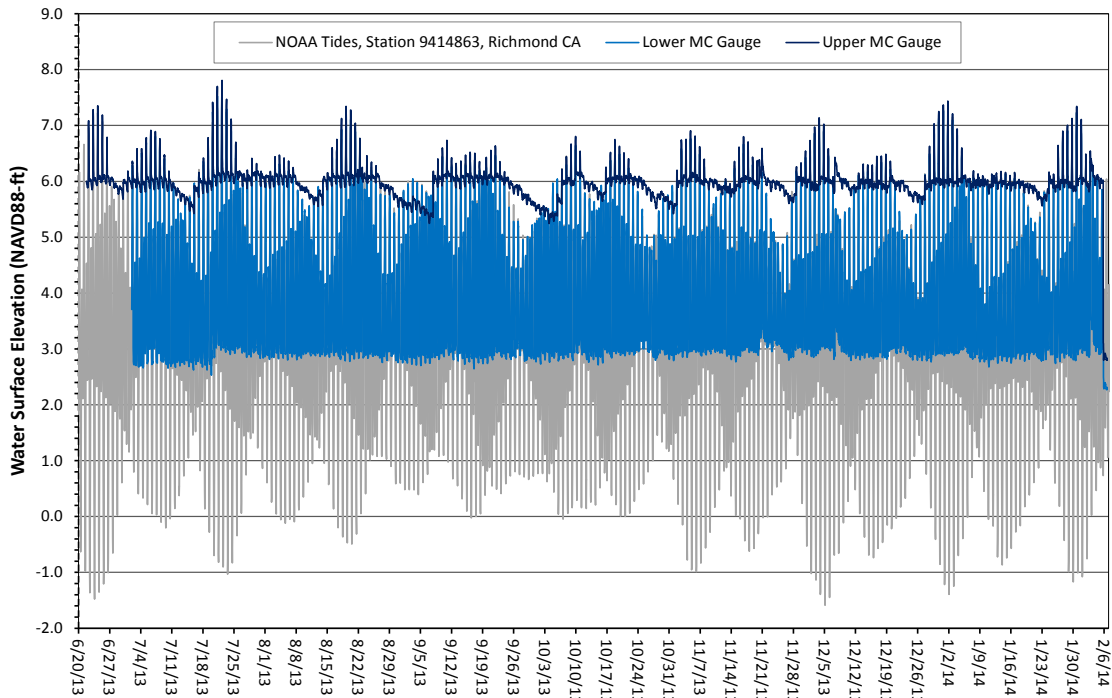
Figure 2-39: Water level monitoring results for Upper and Lower Miller Creek Gauges compared with NOAA tide data from station RCMC1 – Richmond CA. (Period of Record: June 21st, 2013 through February 5th, 2014).

The 2013-2014 KHE tidal monitoring for Lower Miller Creek captures simultaneous measurements of water surface elevations at both gages. This information is valuable because it provides a measurement of the changing water level gradients in the reach. Recorded water levels for the two monitoring locations are plotted in Figure 2-39 and Figure 2-40. Results provide uninterrupted tidal signature for both gauges. Maximum observed tidal range at the

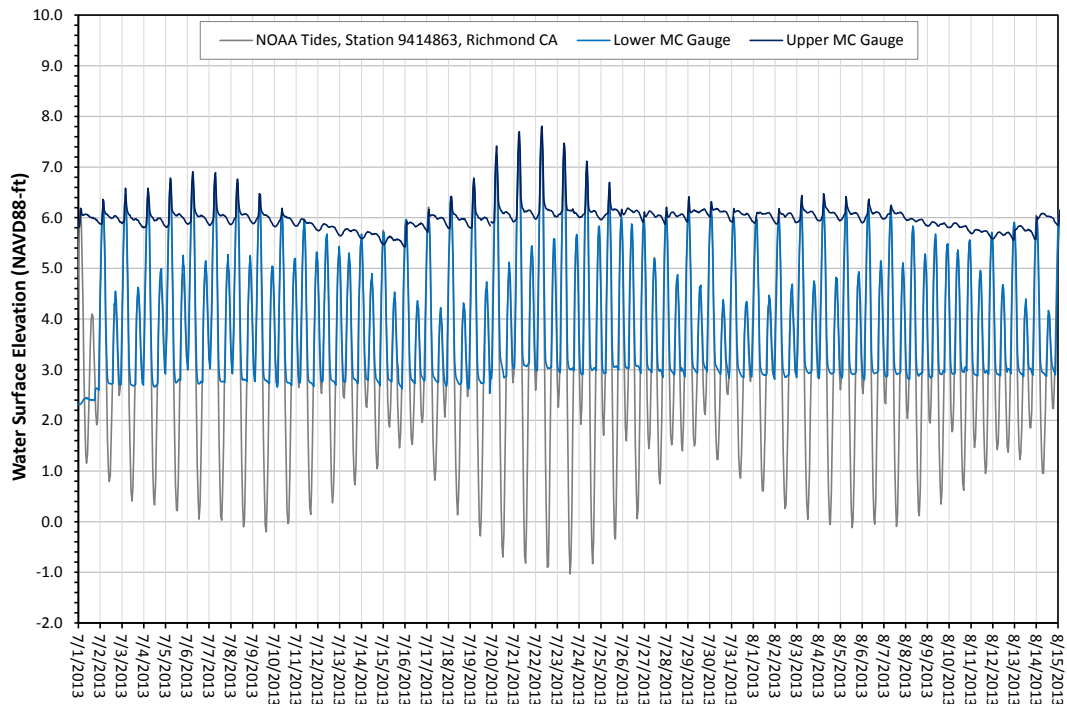
Figure 2-40: Water level monitoring results (expanded) compared to NOAA tide data from station RCMC1 – Richmond CA (time period within period of record: July 1, 2013 through August 15th, 2013).

The lower limit of the water level range for both the upstream and downstream Miller Creek gauges are dependent on local bed elevations. In comparison to NOAA recorded bay tides at Richmond, low tide levels at both Creek gauges were truncated as a result of the rising bed elevation in the Miller Creek channel (see creek profile on Figure 2-38). As noted above, the upstream gauge is installed in a scour pool at the 90-degree bend and there are alternating gravel bars downstream, which truncate the lower tidal range (Figure 2-38). At water levels less than 5.8 feet (NAVD88), the intertidal channel drains leaving residual water in pools. The declining water level below the elevation of 5.8-feet observed in the more upstream pool during low tide periods may be due to longer period changes in groundwater flow gradients which effect rate of subsurface seepage draining the pool. Evaporation losses may also attribute to this decline. Bed elevation at the Lower gauge was approximately 2.3 feet (NAVD88) which was verified by topographic surveys. Truncation at the lower gauge occurred at tides less than 2.9 feet (NAVD88) due to slightly higher bed elevations in downstream bars on Miller Creek.

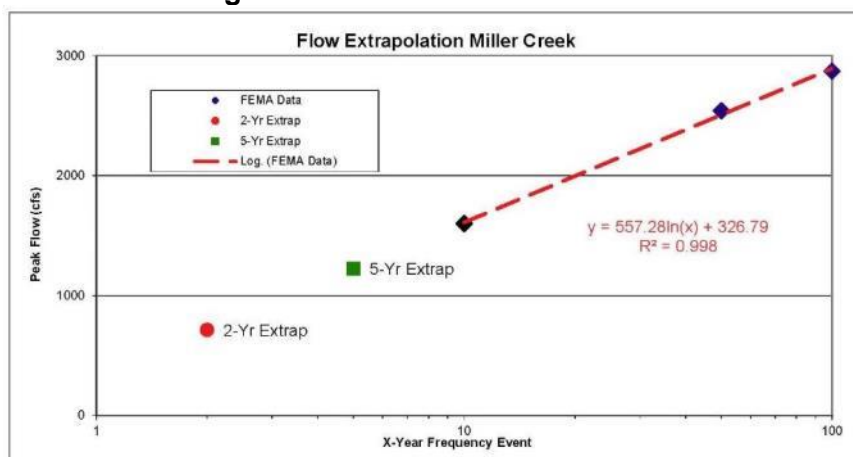
Figure 2-42: Miller Creek design storm vs. flow correlation

Creek flows ranging from the 2- through 100-year peak 24-hour duration storms were simulated using the hydraulic model. The 10-, 50-, and 100-year recurrence interval peak storm flows on Lower Miller Creek are from FEMA at the location of the Southern Pacific Railroad (now SMART) (FEMA, 2009). A logarithmic trend line was fitted to this data to extrapolate the 2- and 5-year recurrence interval peak flow values (Figure 2-42). Additionally, a “low-flow” value of 1-cfs was analyzed to characterize the range of tidal influence under base flow conditions. The flow recorded during the January 20, 2010 storm event was also analyzed; this storm delivered a peak flow estimated to have an approximately 7-year recurrence interval. Miller Creek peak flow, and current estimates of peak flows in the North Fork of Gallinas Creek (Noble, 2012) are provided in Table 2-12.

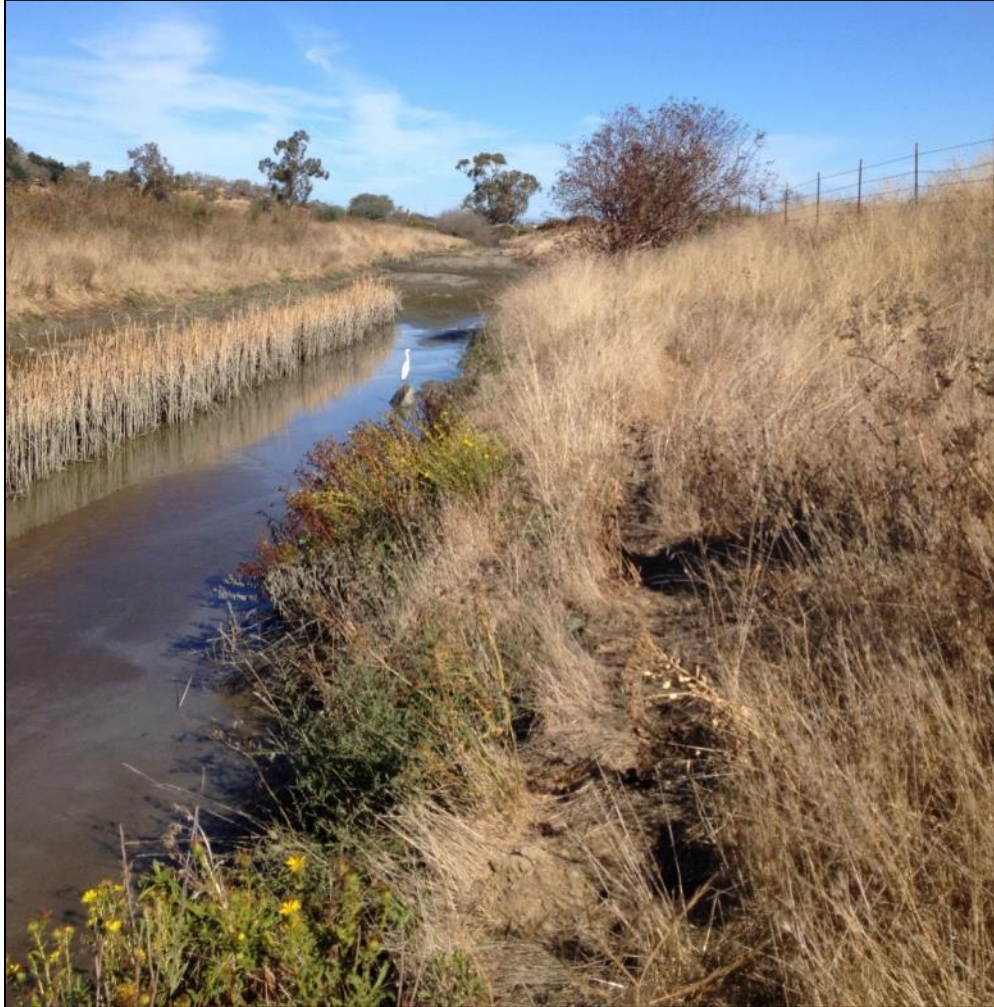
Figure 2-46: Sediment Front in Miller Creek (2014): Looking Upstream from the Silveira pump station.
